13 October 2023

File No: WGN980083

Request for an explanation for the discharge of untreated wastewater due to mechanical failure at Porirua Wastewater Treatment Plant

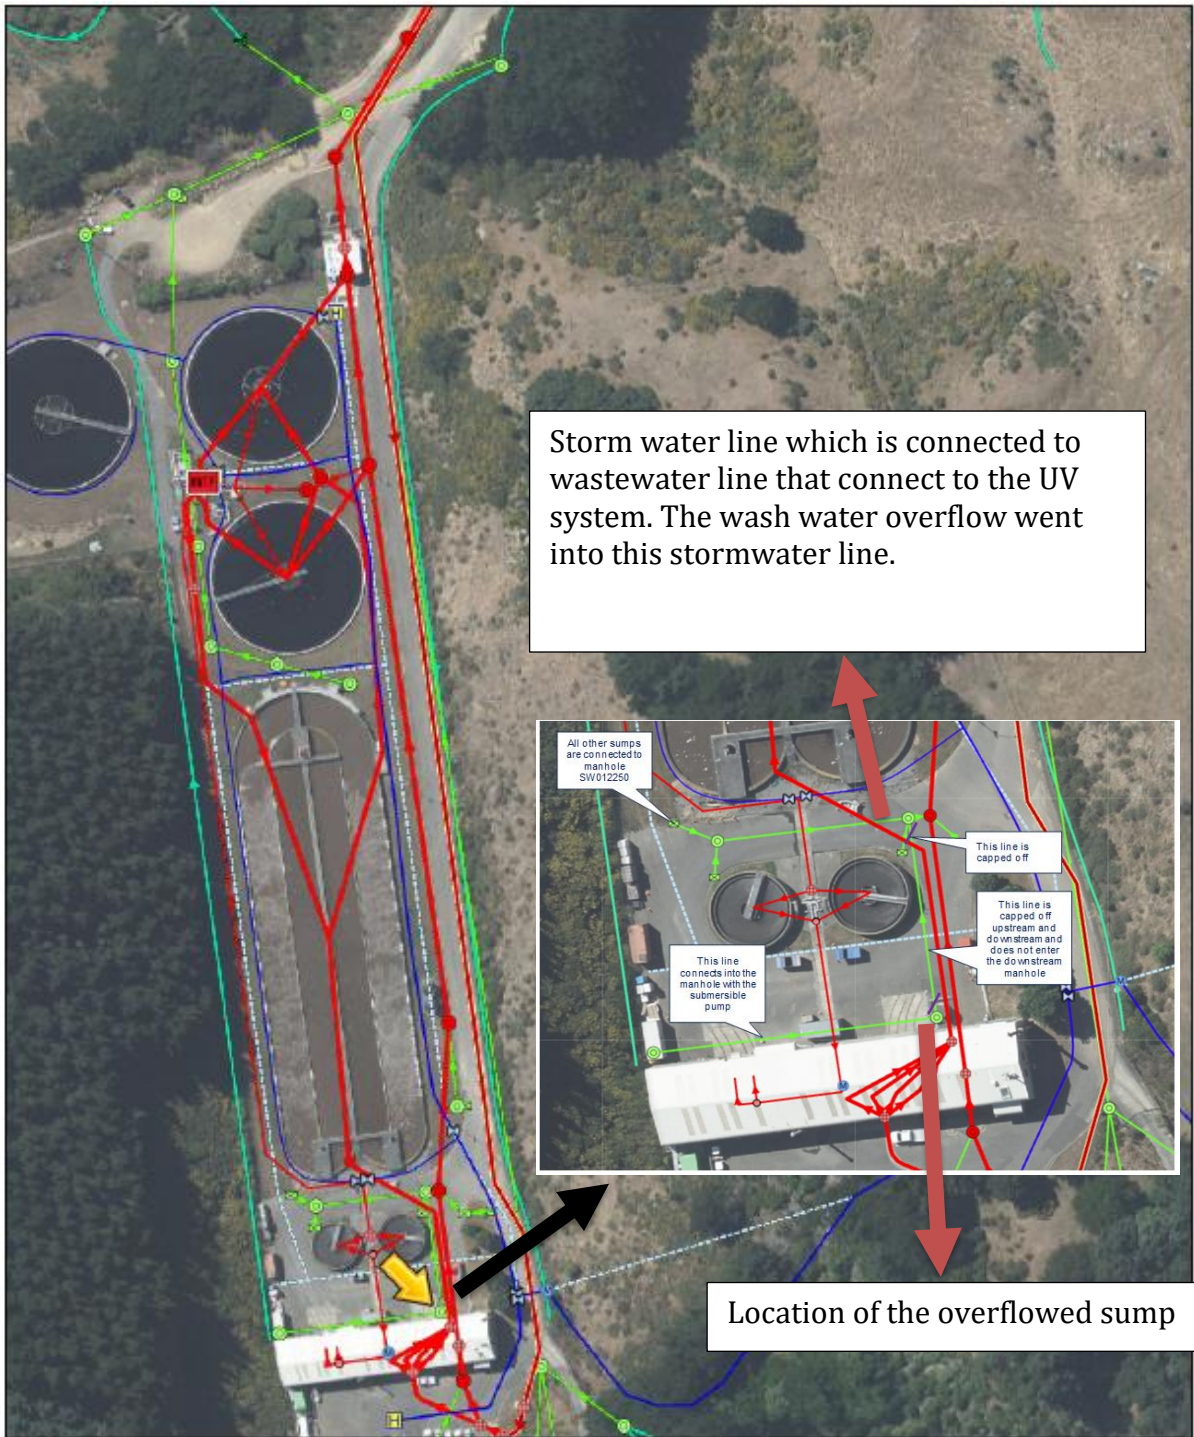
Appendix I: GIS Map

Appendix I is a GIS diagram showing the location of the storm water line and its connection to the wastewater line. Appendix II shows the overflow site. Appendix III shows the Noggerath Screenings Wash machine.

During the recent hydraulic upgrade of the plant there were changes in the stormwater piping connections and there was concern that the stormwater drain was connected to the overflow bypass channel which conveys directly to the CMA. Upon further investigation, it was confirmed that the pipework was changed during the project and the stormwater drain conveys to the treated effluent in pre-UV channel. From this point it is diluted with treated effluent before being disinfected by the UV system.

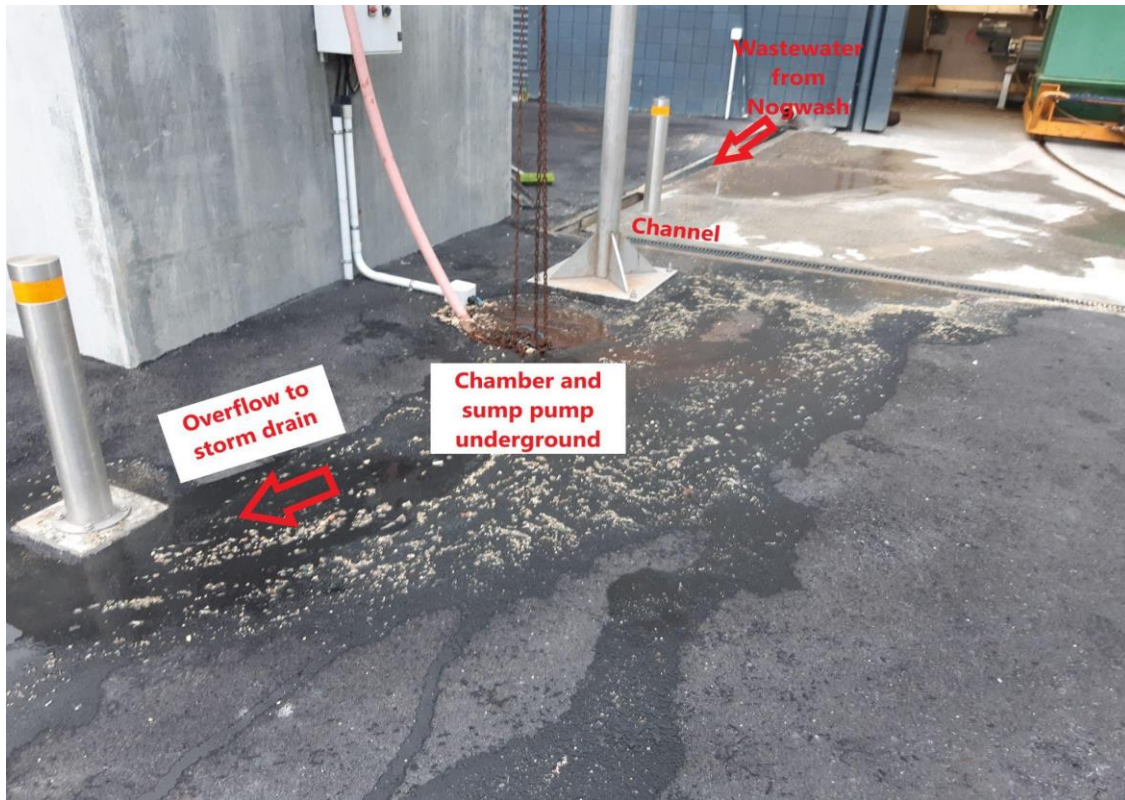
Appendix II: Overflow site

Veolia was unable to determine the exact start time and duration of the incident. The discharge occurred sometime between 1st October 11:45am and 2nd October 7:30am when the operator arrived on site stopping the discharge. Assuming a maximum duration of 19 hours and 45 minutes, the estimated total volume of discharge was approximately 85 cubic meters. The volume of fully treated wastewater during the assumed discharge duration was 21,709 cubic meters, which will have significantly diluted the partially treated wastewater further. The UVT results shown in Appendix V also support this. The discharge volume noted is the worst-case volume estimate.

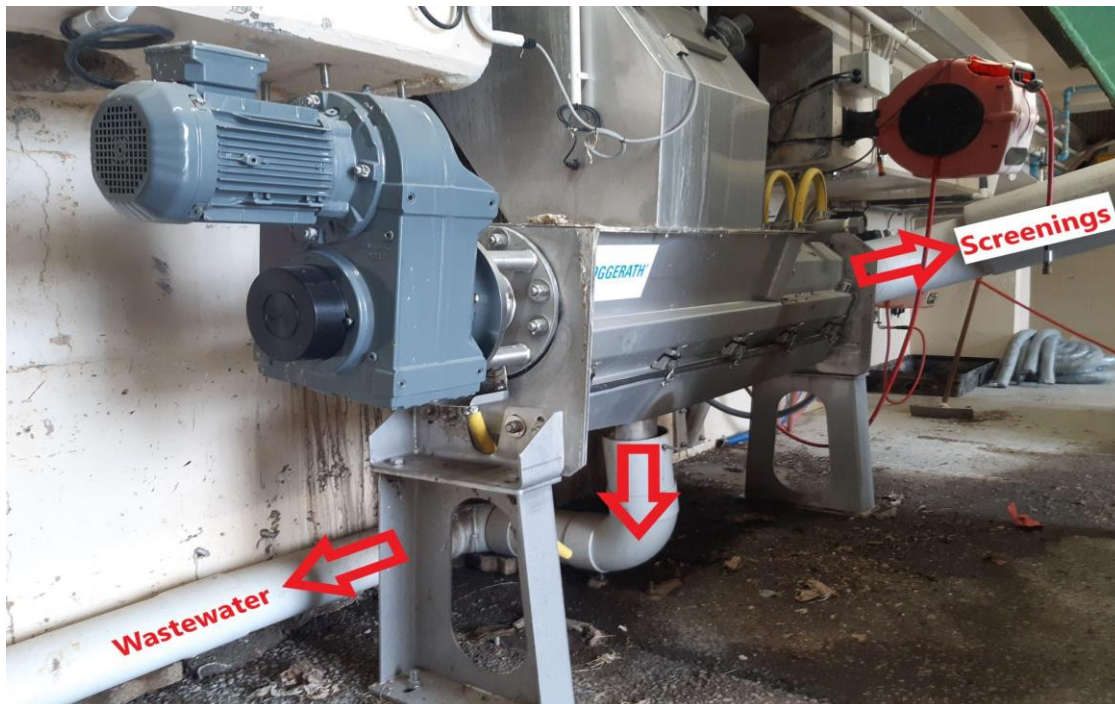
Appendix III: Noggerath Screenings Wash Machine

The screenings (i.e. rags, paper, etc.) is removed from the wastewater by milliscreening, are conveyed to a Noggerath wash machine (often referred to as Nogwash) which uses recycled fully treated effluent water to clean/press these screenings making them drier/lighter. The screenings are conveyed to a skip bin for landfill disposal and the wash water from the machine goes to an underground sump chamber. A single submersible pump then pumps this wash water to the aeration basin. The discharge occurred due to this sump pump becoming blocked with rags causing the level in the sump to rise and escape via a manhole where it was then able to run into a nearby stormwater drain. The subsequent investigation discovered this stormwater drain connects to the inlet channel of the UV system where it mixes with the treated wastewater prior to UV disinfection before being discharged to the coastal marine area via the short outfall.

The Noggerath machine cleans the screenings taken from the milliscreens using fully treated recycled effluent water from the plant. The wash water conveys to the aeration basin via a sump pump. This pump failure meant it bypassed this biological and sedimentation process (clarifiers). Instead, the wash water conveyed to a nearby stormwater drain and into the pre-UV channel where it mixed with treated effluent and was UV disinfected before being discharged to the CMA.

The sump pump did not have any instrumentation connected which would enable an alarm to notify the operators when it failed. As a result of the discharge, work is underway to rectify this by allowing the pump status to display on the SCADA system, automatically alerting operators immediately if the pump faults.

Work is underway to allow the pump status to display on the SCADA system, automatically alerting operators immediately if the pump faults. The contractor to perform the work has been engaged and it is expected to be completed before the end of October.

and a work order has been created on their VAMS system. The pump itself is part of a quarterly PM schedule and records show good performance, indicating another blockage soon is highly unlikely. However, WWL has asked Veolia to carry out a weekly check on the pump until the alarm is fitted on the pump to further reduce any risk.

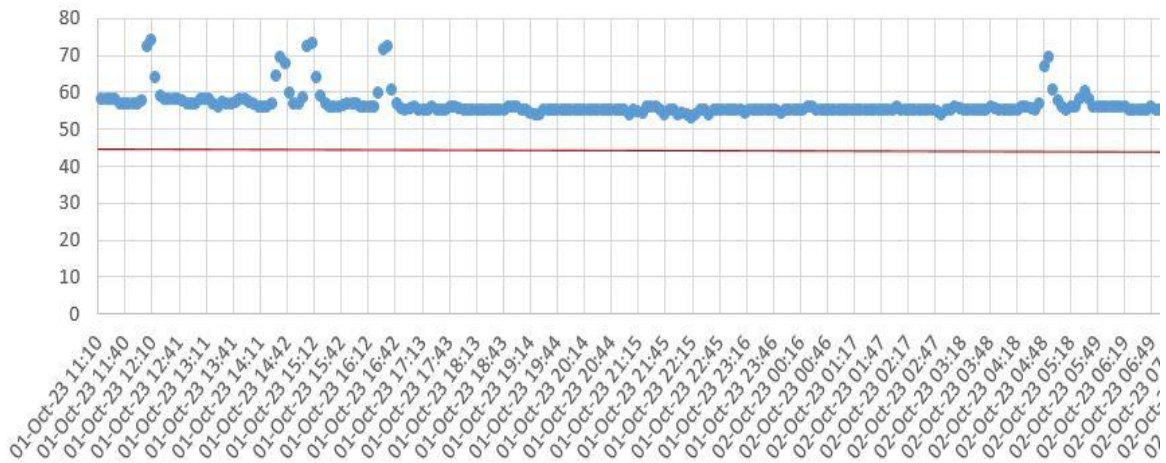
Appendix V: UVT (%) Disinfection Channel

Veolia have provided a graph showing the UVT readings from the UV disinfection channel during the incident. The graph shows no significant drop in UVT indicating there was no negative effect on the effluent quality and therefore no effect on the receiving environment. This graph is shown in Appendix V.
