Incident Investigation Report: Porirua Faecal Coliforms Non-Compliance (2,3,4 & 5 July 2024)

Document Title:	Investigation report_Porirua Faecal Coliforms non-compliance (2,3,4 & 5 July 2024)
Prepared by:	[REDACTED]
Reviewed by:	[REDACTED]
Authorised by:	[REDACTED]

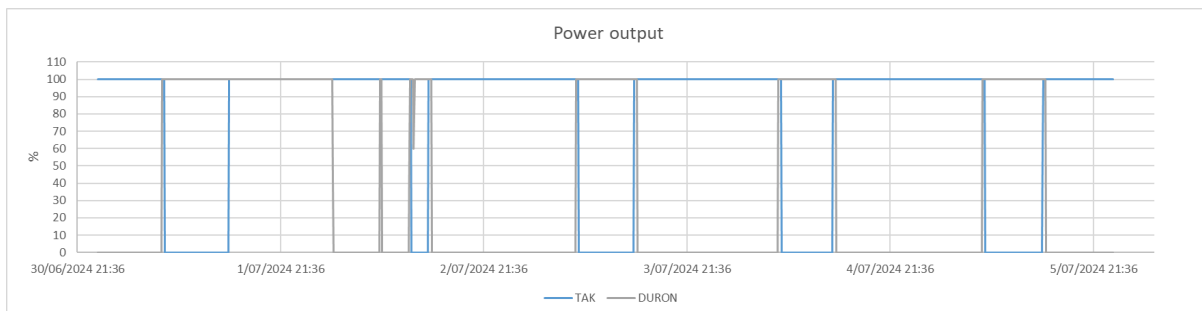
Figure 1 Power outputs for Duron and TAK UV systems

Based on the data for the year 2024, there is a difference in the UV systems removal efficiency. Average log removal values are 3.2 and 2.2 for Duron and TAK UV systems respectively indicating lower disinfection performance of the TAK system.

Both UV systems are operated with 100% output to provide maximum disinfection efficiency possible (see figure 1).

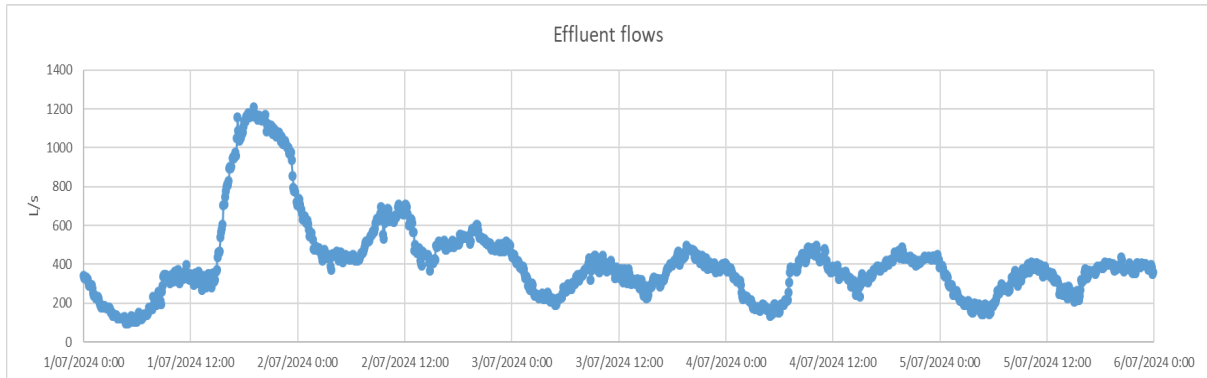
Figure 2: Faecal coliforms counts

A rain event that starting on 1 July 2024 caused increased flows entering the plant. The flows returned to the average range during the 3 July. During the rain period the average flow was 624 L/s with peak of 1200 L/s.

The UV channels operate in duty/assist systems. Once the flow exceeds 750 L/s, the assist channel is activated to maintain the required retention time/UV dose.

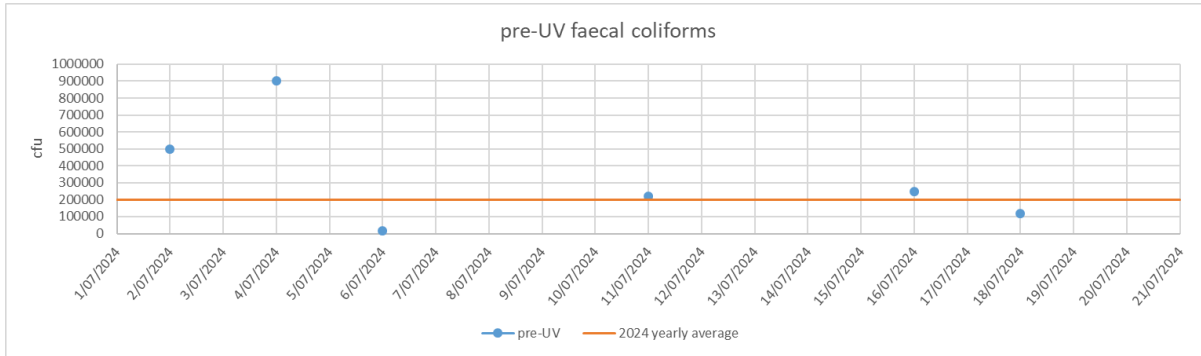
Figure 3: Pre-UV coliforms

Figure 3 shows pre-UV faecal coliform counts during the month of July. Orange line represents an average value for the year 2024 (201 269 cfu/100 ml).

Pre-UV faecal coliform counts are analysed twice a week (Tuesdays and Thursdays) and during the investigated period (2- 5 July) the average value was increased significantly which indicates higher demands on the UV disinfection systems.
