**Porirua WWTP Investigation Report**

**Faecal Coliform exceedances: February 2024**

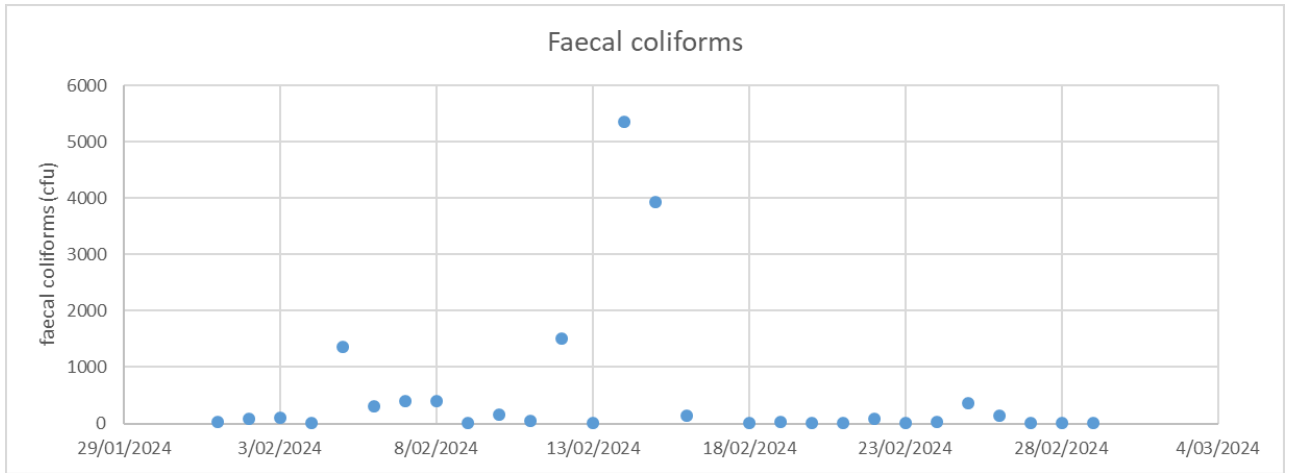
**Figure 1: Faecal coliforms count**

Figure 2 below shows Faecal coliforms counts during the month of February indicating the spikes on February 14<sup>th</sup> and 15<sup>th</sup>.

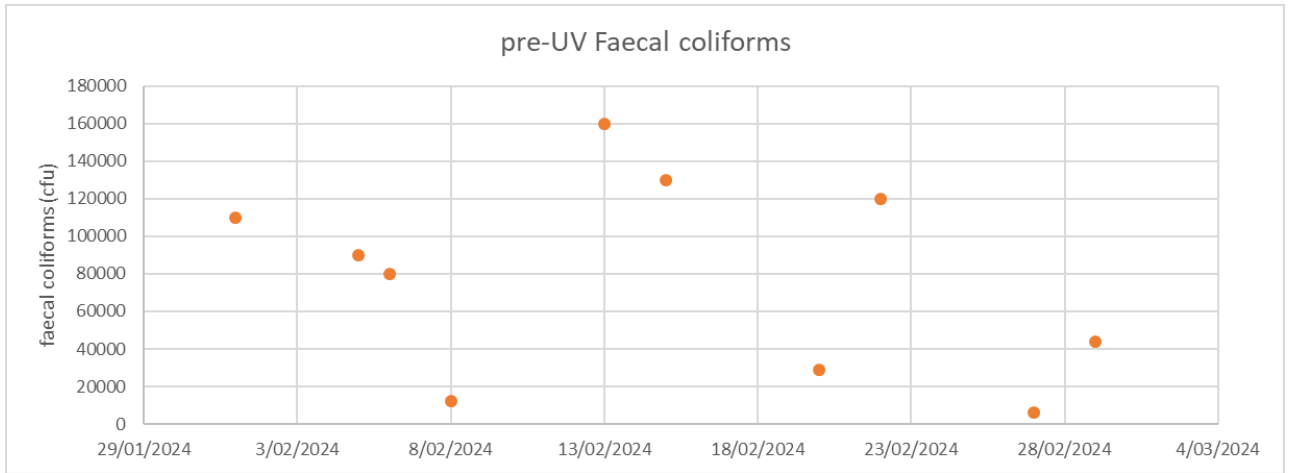
**Figure 2 :Pre-UV Faecal Coliforms Results for February 2024.**

The sampling for the pre-UV is conducted twice a week on Tuesdays and Thursdays therefore only the result for the 15th of February is available however the long-term trend in pre-UV confirms counts shows that there were no concerning spikes.

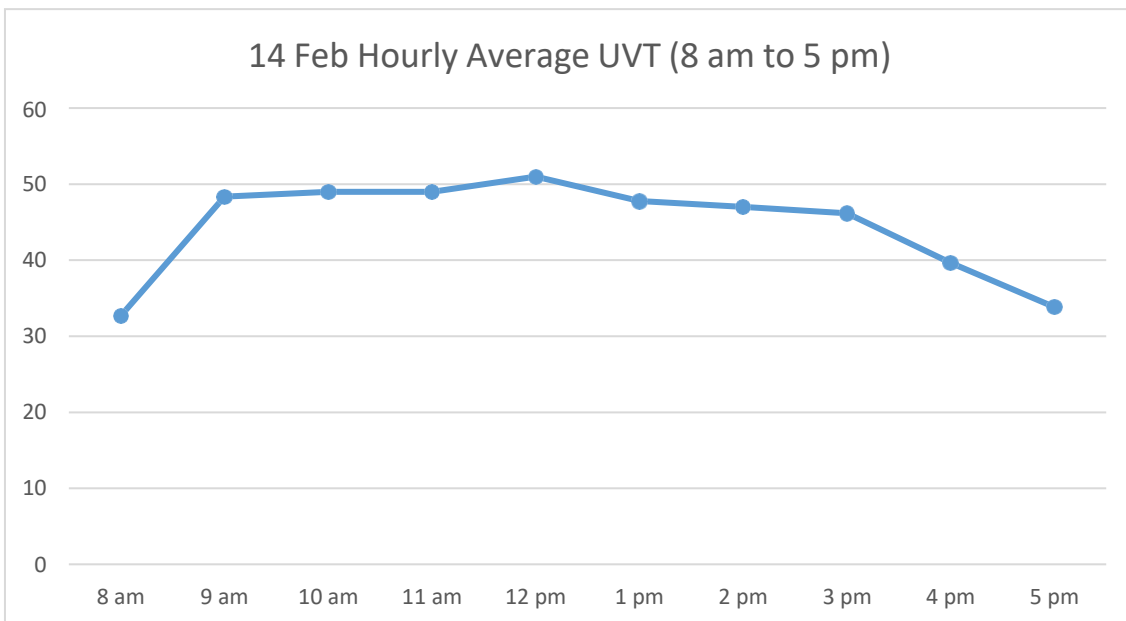
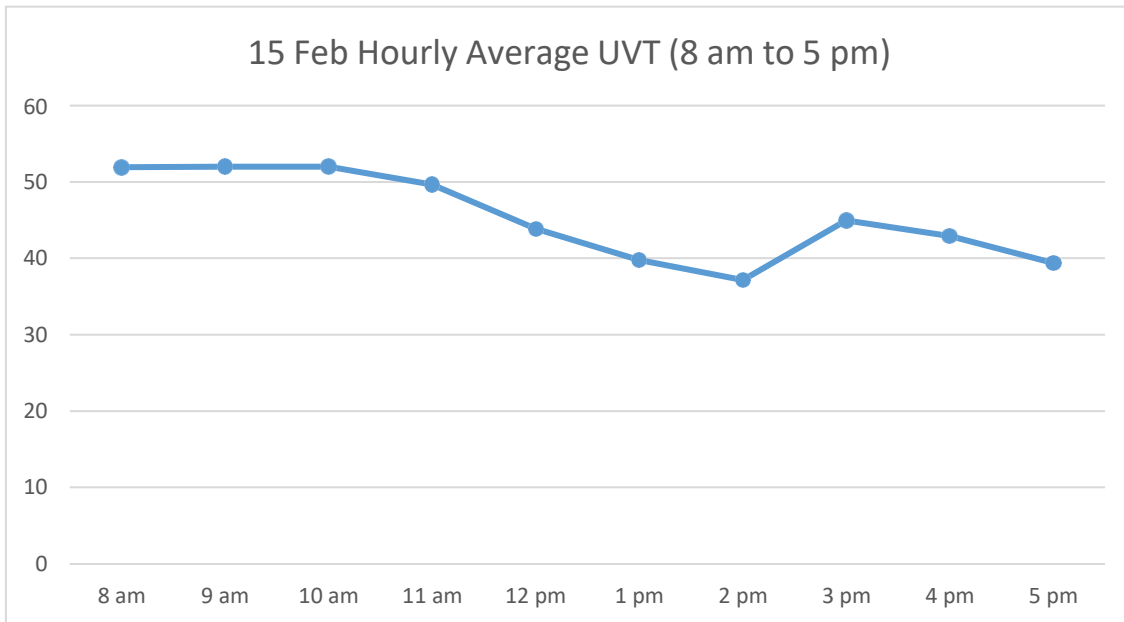
Trends for the online UV transmissivity readings from the are given below. The samples were taken around 8:30 am with UVT records showing good UVT Results in the morning when the sample was collected.
